RESTORATION OF THE GRAIN CLEANER AT FELINGANOL WATERMILL, LLANRHYSTUD, SPRING 2016

Andy Parry

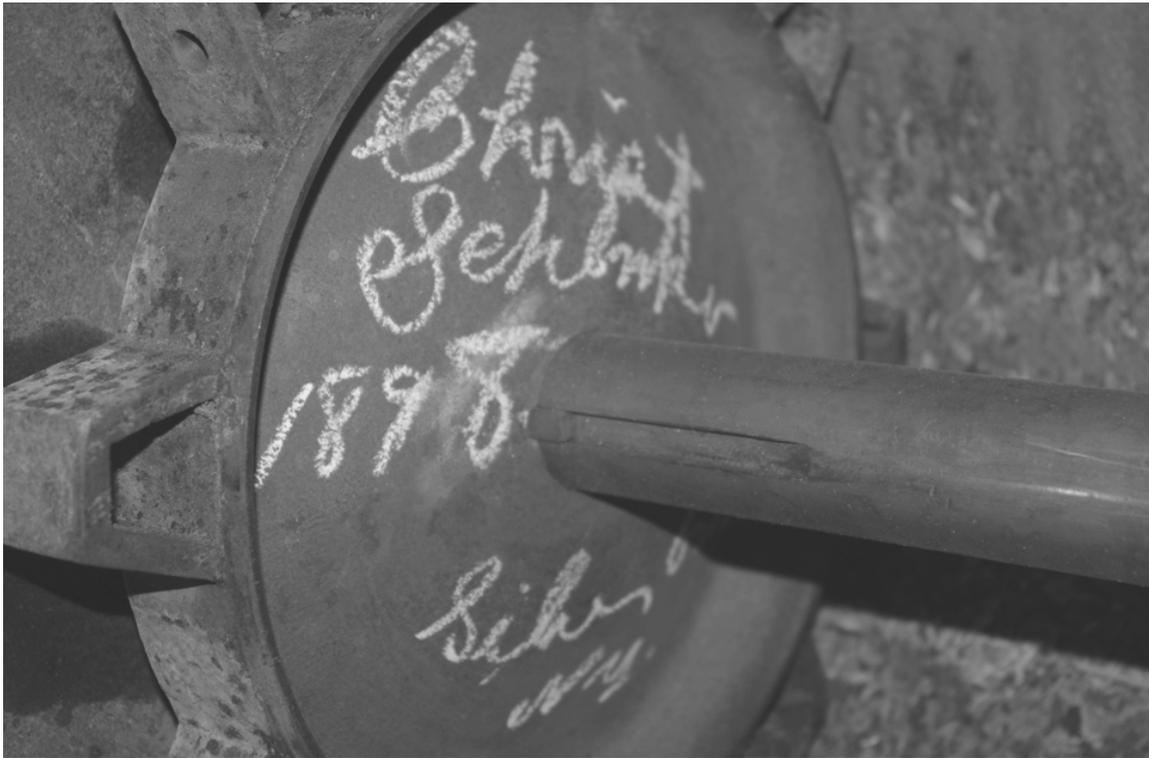
The main shaft of the cleaner was remarkably clean and still bore the name of the man who presumably assembled it and more significantly, the date – 1898 (Plate 1). This, of course, does not necessarily mean that the cleaner arrived at the mill in that year but it does fit in well with our assumption that these major modifications to the mill took place in the last half of

PLATE 1 Main shaft of the cleaner

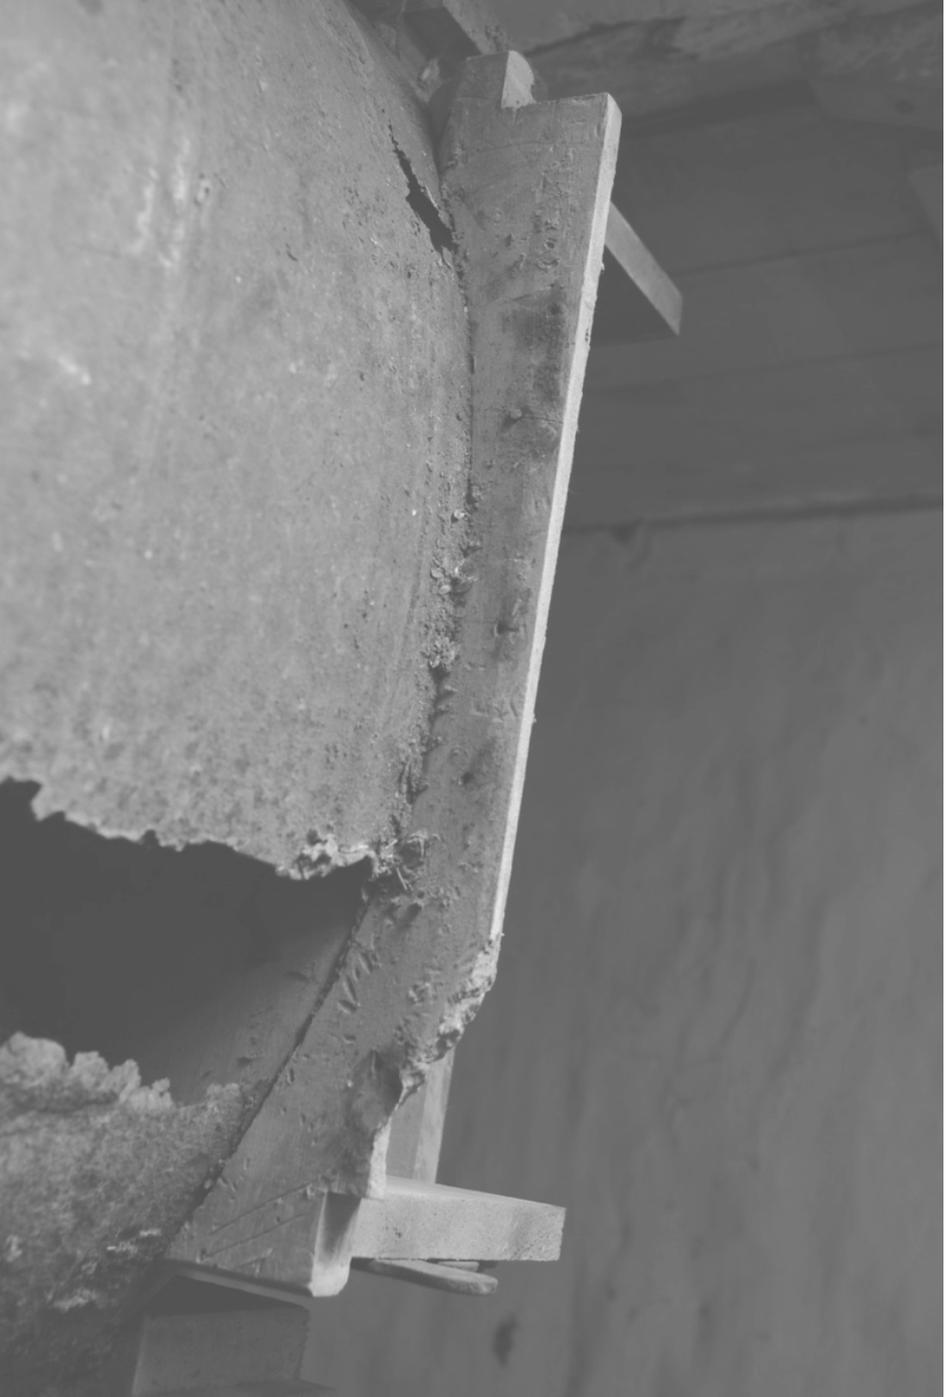
PLATE 2 Condition of the fan housing before repair

A new housing was made from galvanised sheet and new fan blades were installed as the old ones were badly corroded.

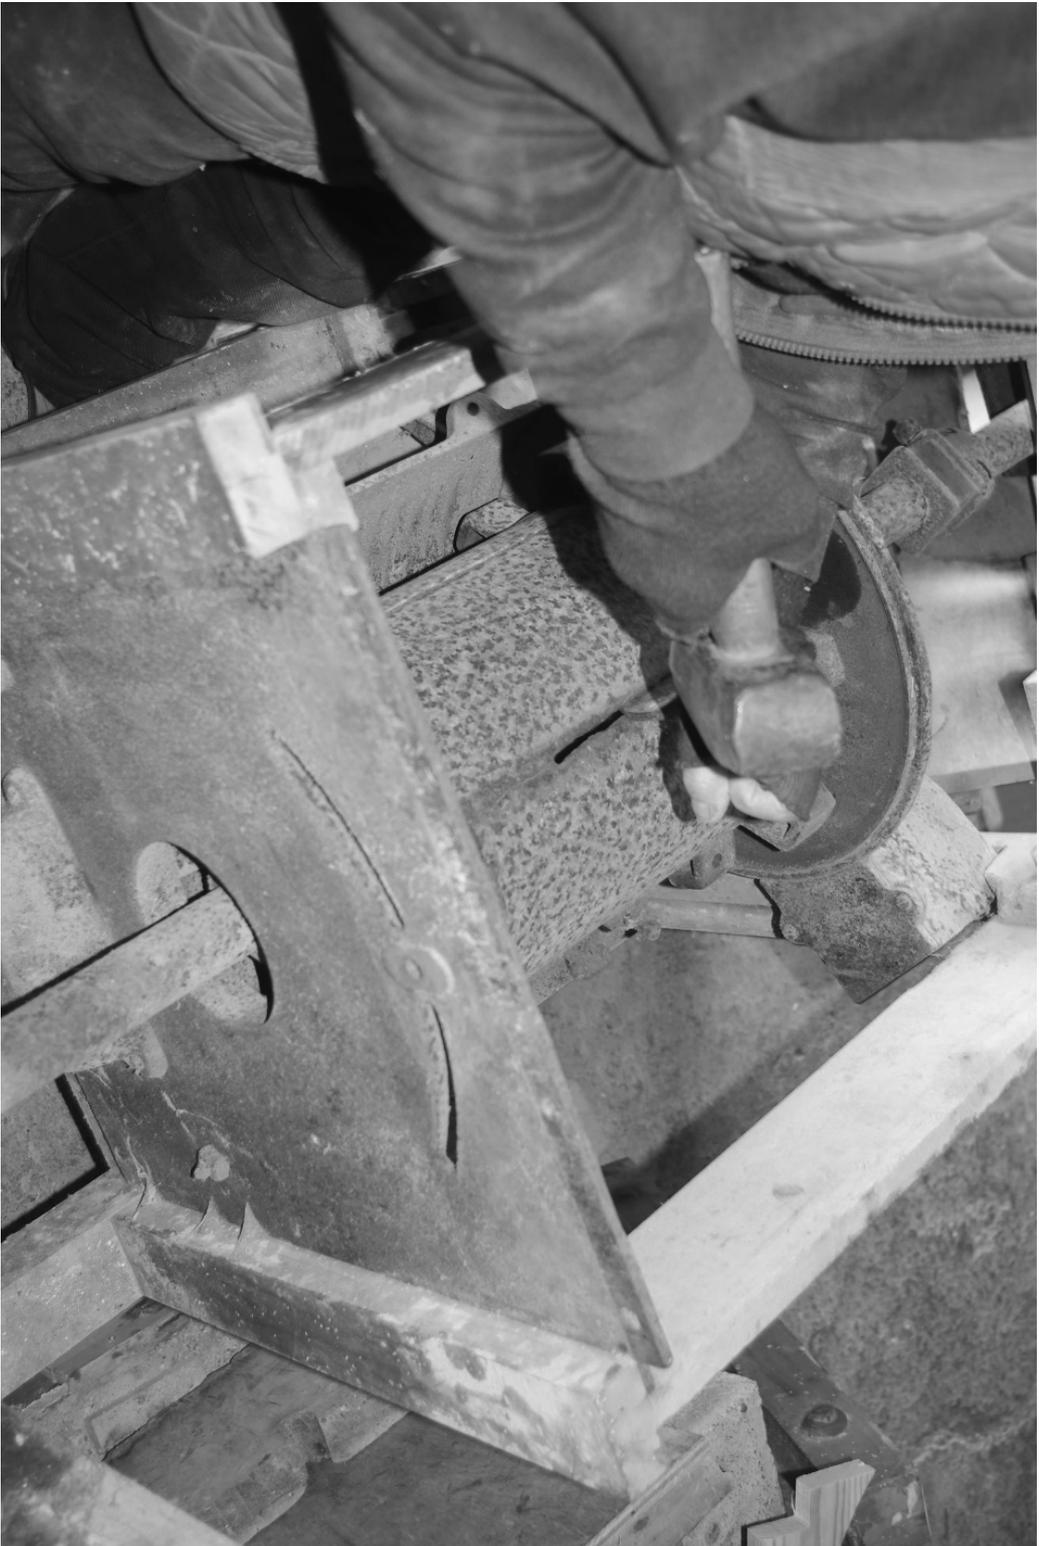
PLATE 3 Removing the corroded drum from the 'smutter'

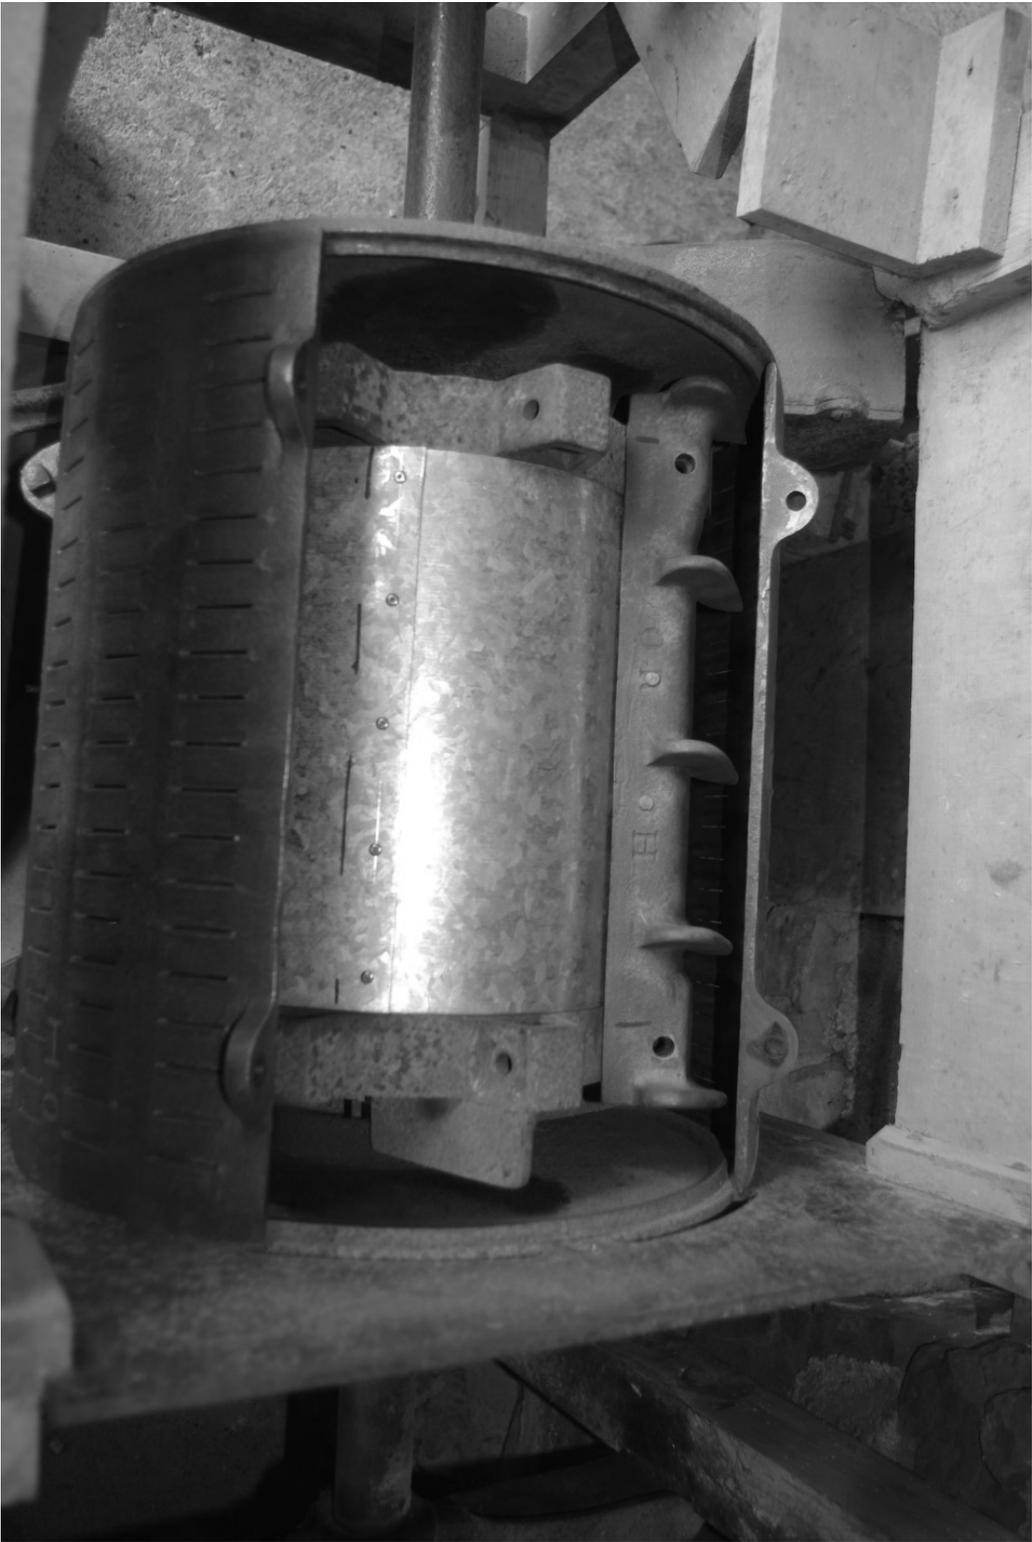
PLATE 4 The replacement drum with one of the cast iron vanes ready for bolting into position

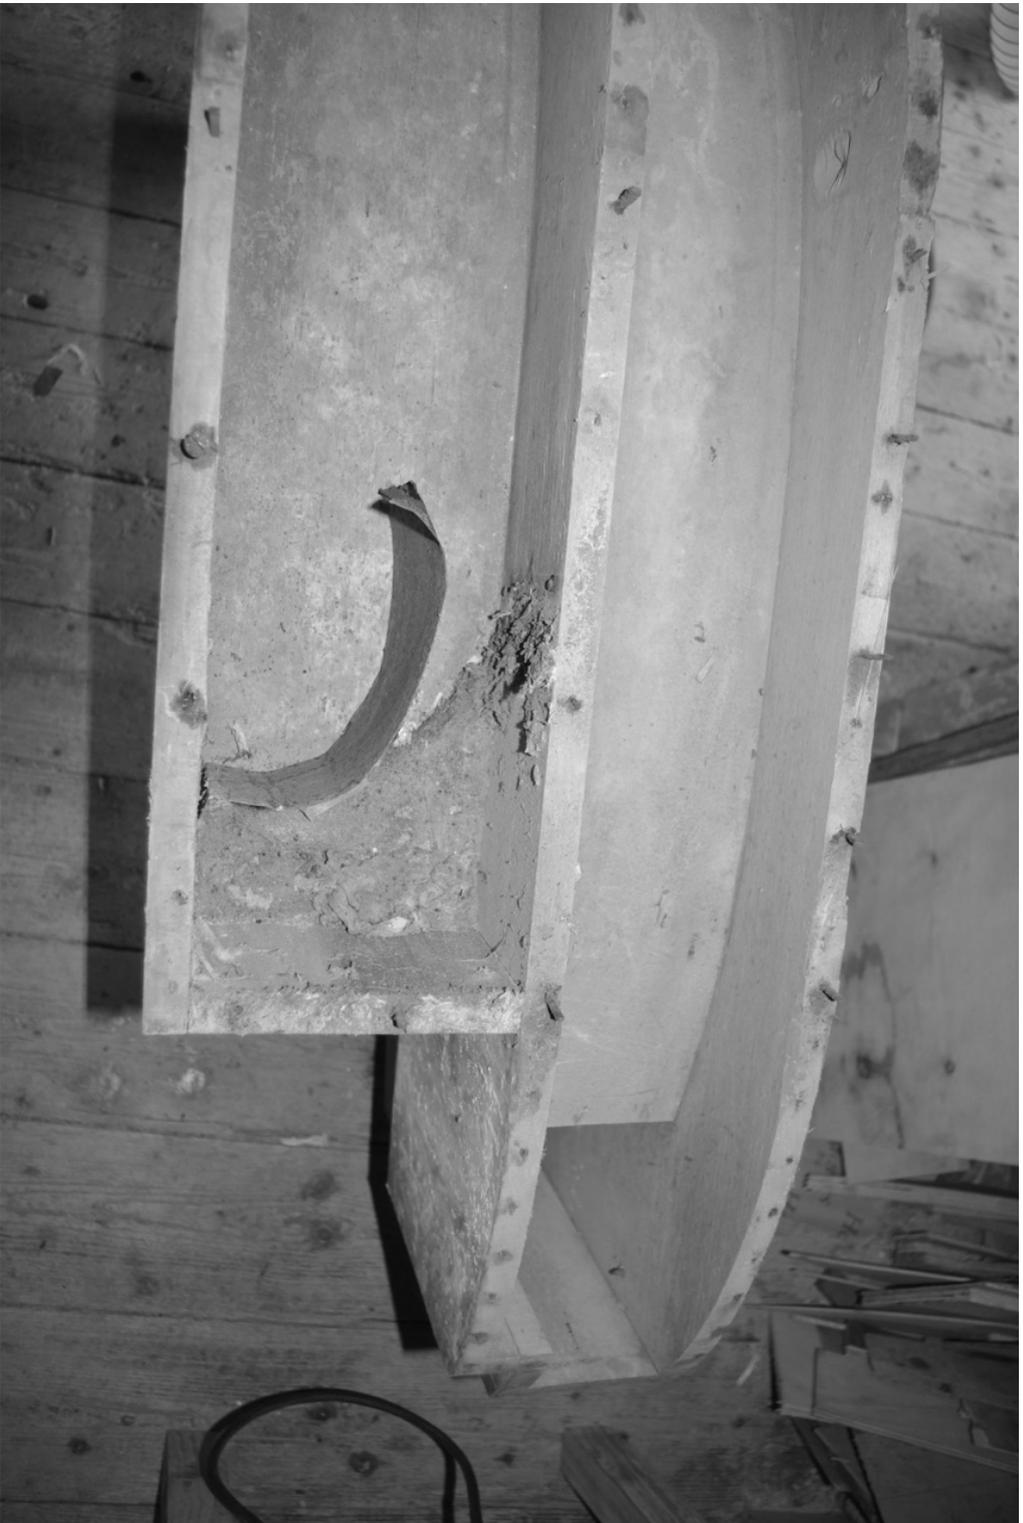
Plate 5 shows the two channels of the plenum chamber. The wood here was worth preserving so we simply cleaned it up and renewed the metal covering. We used panel pins as in the original except that the new ones were stainless.

PLATE 5 The two channels of the plenum chamber

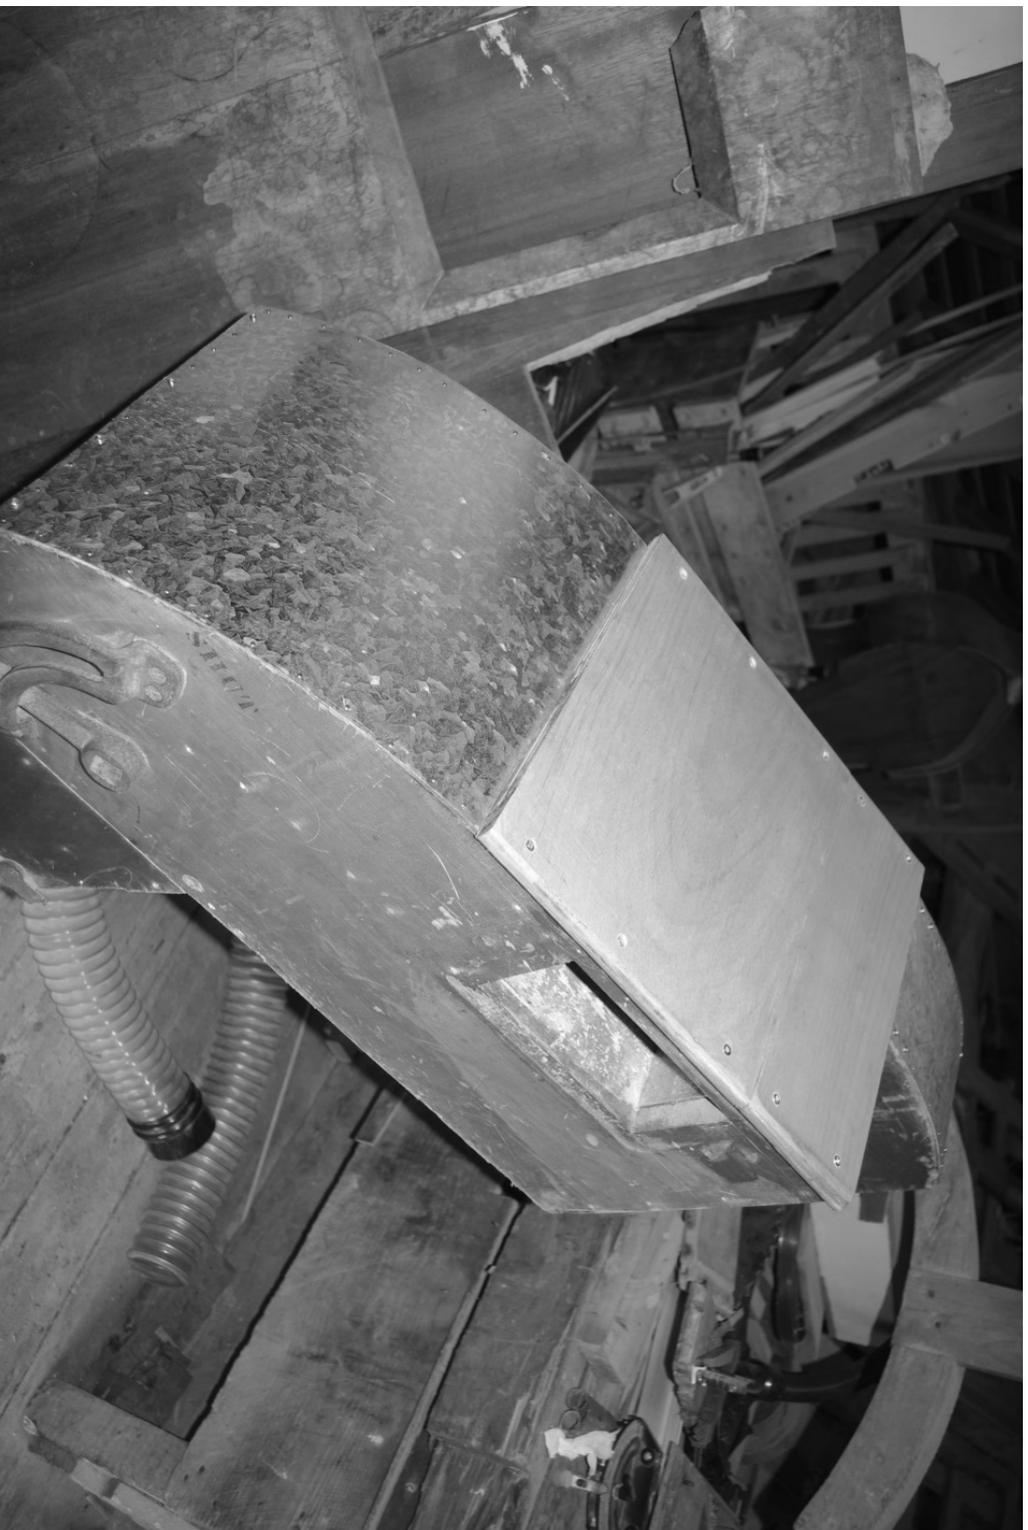
PLATE 6 Restored plenum chamber

Plate 6 shows the lever with “Shut” stencilled next to it. This was supposed to vary the draught and presumably control what debris fell down the shute. In our experience only a modest amount of chaff appears at this point in the process, the bulk of what comes off in the smutting chamber gets sucked out through the fan and out through the chaff tunnel. A good deal is separated at the sieving stage before it reaches any air draught. The aperture visible on the right connected to another duct and received any airborne debris from the final fall of cleaned grain down the output shute.

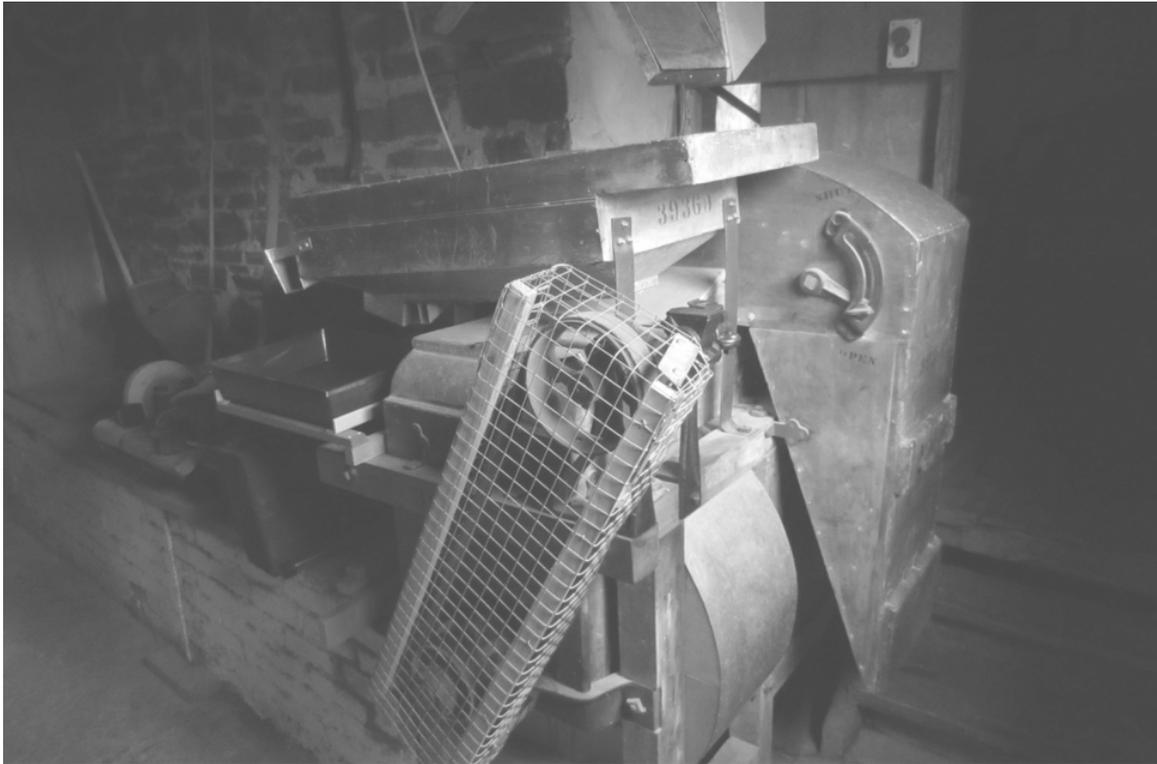
PLATE 7 Restored grain cleaner

The black plastic tray is an improvisation to collect the material from the three sieving screens. The spout of the feed hopper can be seen at the top of the picture. In operation a container would normally be placed under the flaps from the two spouts on the bottom right. These are supposed to vent automatically when enough material has gathered behind the flap to push it open.
